Smoke and Dye Testing Summary

High Level Sewershed

Test ID	Test Type	Date Inspected	Company / Super.	Blower MH	Ground Condition	Notification Made?	Total Length
S1028-026	Smoke	8/13/2008	ADS/TM	S07WW_010MH	Dry	Yes	281.88

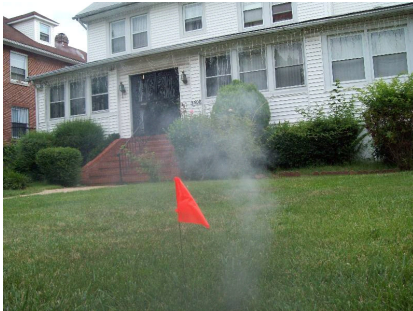
Picture \S1028-026-OB01-P01.jpg

Comments Smoke from cleanout in front yard. 3508 Liberty Heights Ave.

Comments Front of house, 3508 Liberty Heights Ave.

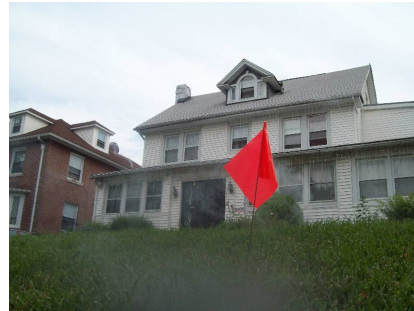
Picture \S1028-026-OB02-P01.jpg

Comments Smoke from ground near water meter. 1 ft. from public sidewalk. 3508 Liberty Heights Ave.

Comments Smoke observed near public sidewalk at 3508 Liberty Heights Ave.

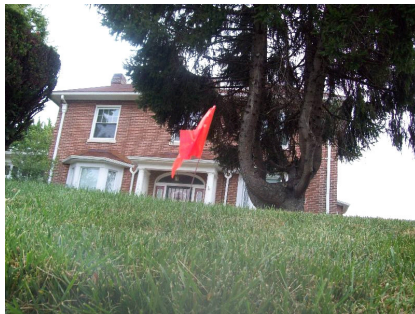
Picture \S1028-026-OB03-P01.jpg

Comments Smoke 1 ft. from sidewalk along main sewer line. 3510 Liberty Heights Ave.

Comments Smoke from main sewer crack. Front of house, 3510 Liberty Heights Ave.

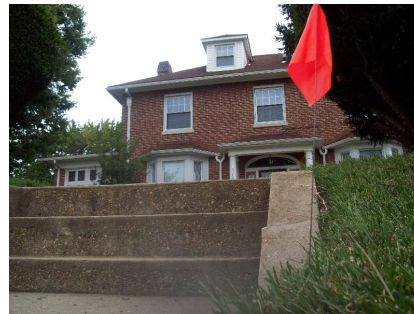
Picture \S1028-026-OB04-P01.jpg

Comments Smoke near stairs of private walkway along main sewer. 3510 Liberty Heights Ave.

Comments Smoke from main sewer crack. Front of house, 3510 Liberty Heights Ave.

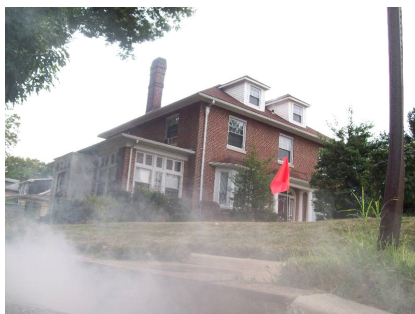
Picture \S1028-026-OB05-P01.jpg

Comments Smoke at catch basin on NE corner of Liberty Heights Ave & Grantley Rd.

Comments Liberty Heights Ave & Grantley Rd facing northeast

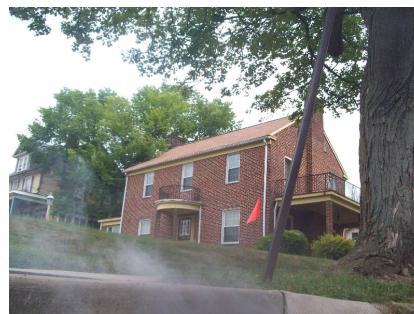
Picture \S1028-026-OB06-P01.jpg

Comments Smoke at catch basin on NW corner of Liberty Heights Ave & Grantley Rd.

Comments Liberty Heights & Grantley Rd facing northwest

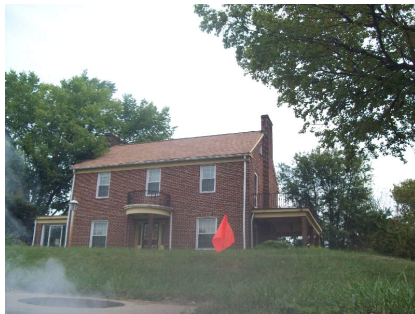
Picture \S1028-026-OB07-P01.jpg

Comments Smoke at catch basin on NW corner of Liberty Heights Ave & Grantley Rd.

Comments Liberty Heights Ave & Grantley Rd facing northwest

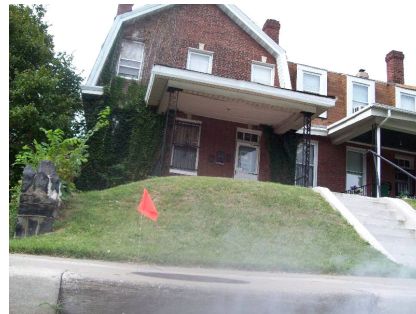
Picture \S1028-026-OB08-P01.jpg

Comments Smoke at catch basin on SW corner of Liberty Heights Ave & Grantley Rd.

Comments Liberty Heights Ave & Grantley Rd looking southwest
